# Referral of Industrial Wind Turbines Under Market Surveillance of The Machinery Directive

Non Conformance of Wind turbines to Design and  
CE Certification Criteria.

By John Dooley

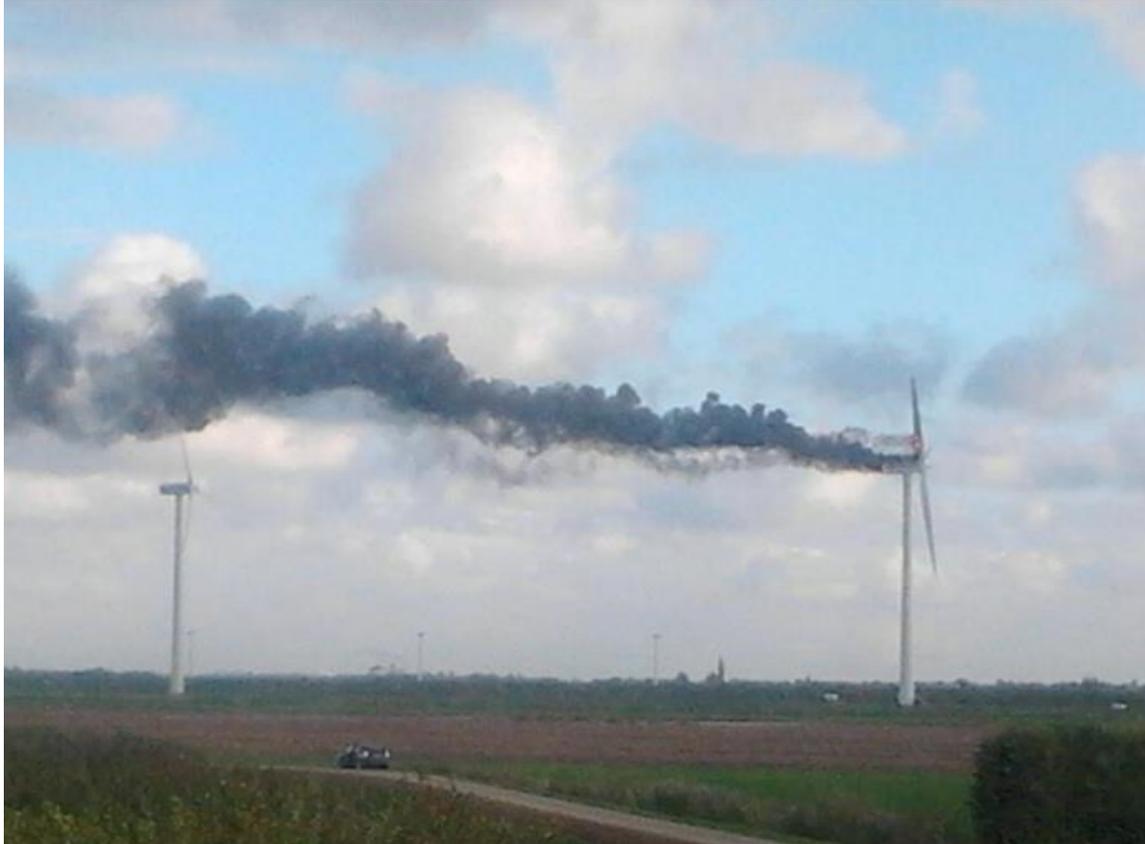
**Fig 1 The Piet De Witt Turbine Fire in which two technicians lost their lives 2013**

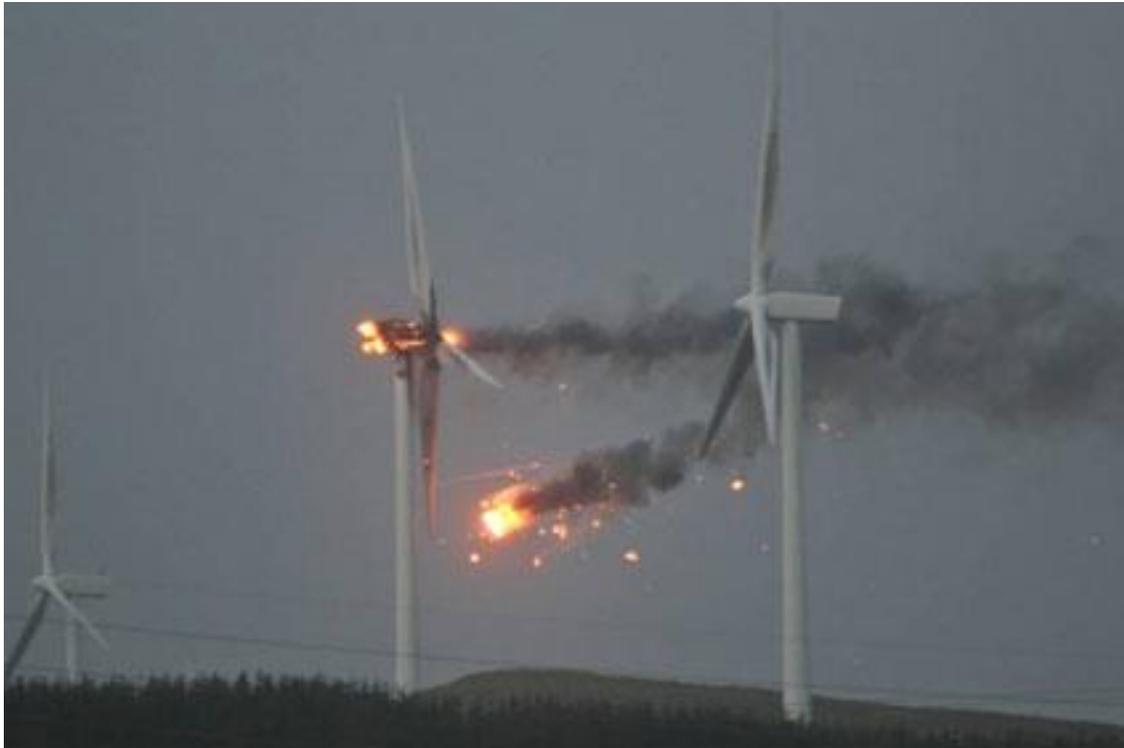
**Fig 2 Ardrossan Vestas V80 burst into fire during storm 55 mph (24.6 m/s) winds. Caused by loss of yaw control due to gearbox failure so that feathered blades could not be pointed into the wind. The turbine head then moved back and forth in the wind. Generating extreme heat sparking a fire in the generator enclosure (The Nacelle). This wind speed is close to the cut out speed for this turbine.**

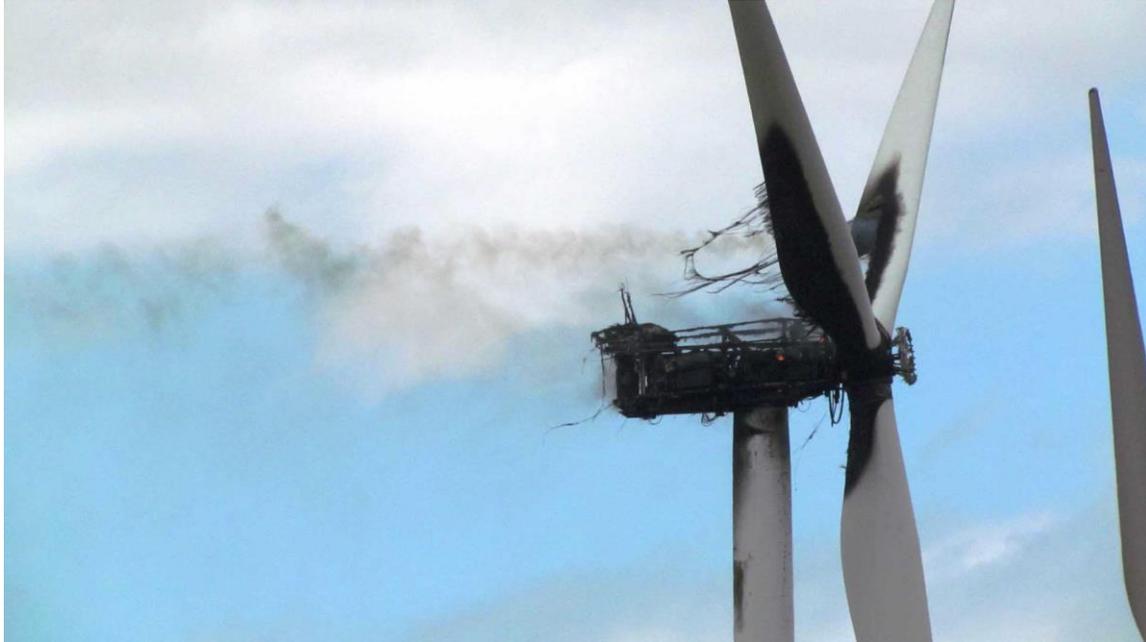
**Fig 3 Gamesa G80 Bii Nee Stipa Wind Farm, Mexico. The same model turbine in Corkermore Wind Farm. The wind farm was recently renamed Stipa Nayaa . <http://www.windpowermonthly.com/article/1223507/gamesa-investigates-g80-fire-oaxaca>**

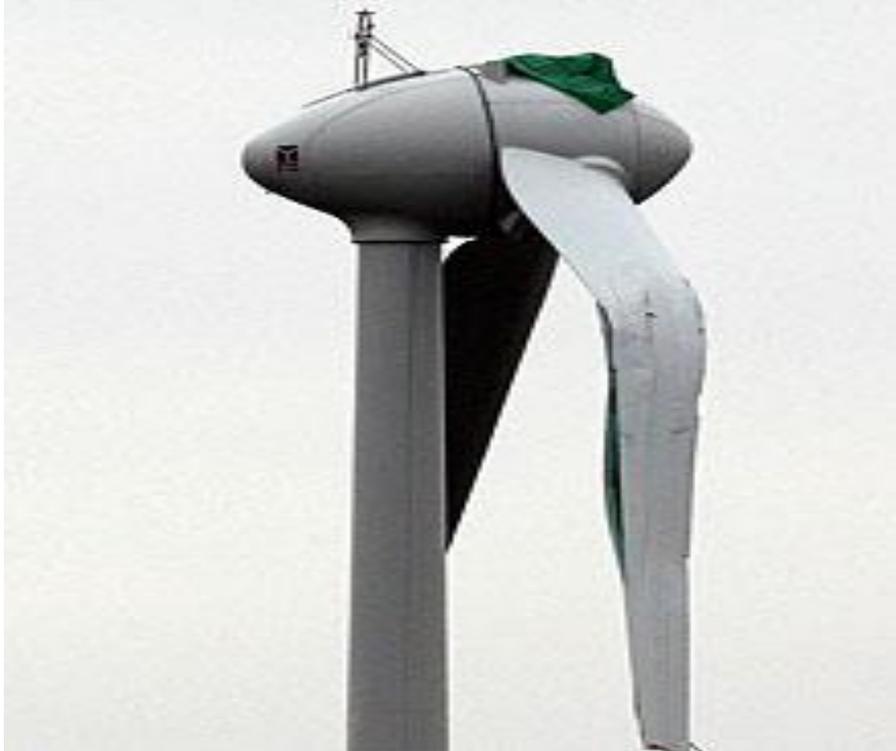
**Fig 4 Enercon E48 At Fenn Farm Conisholme UK 10<sup>th</sup> February 2009 aged 6 years. Detachment caused by metal Fatigue. Observers blamed a UFO strike.**

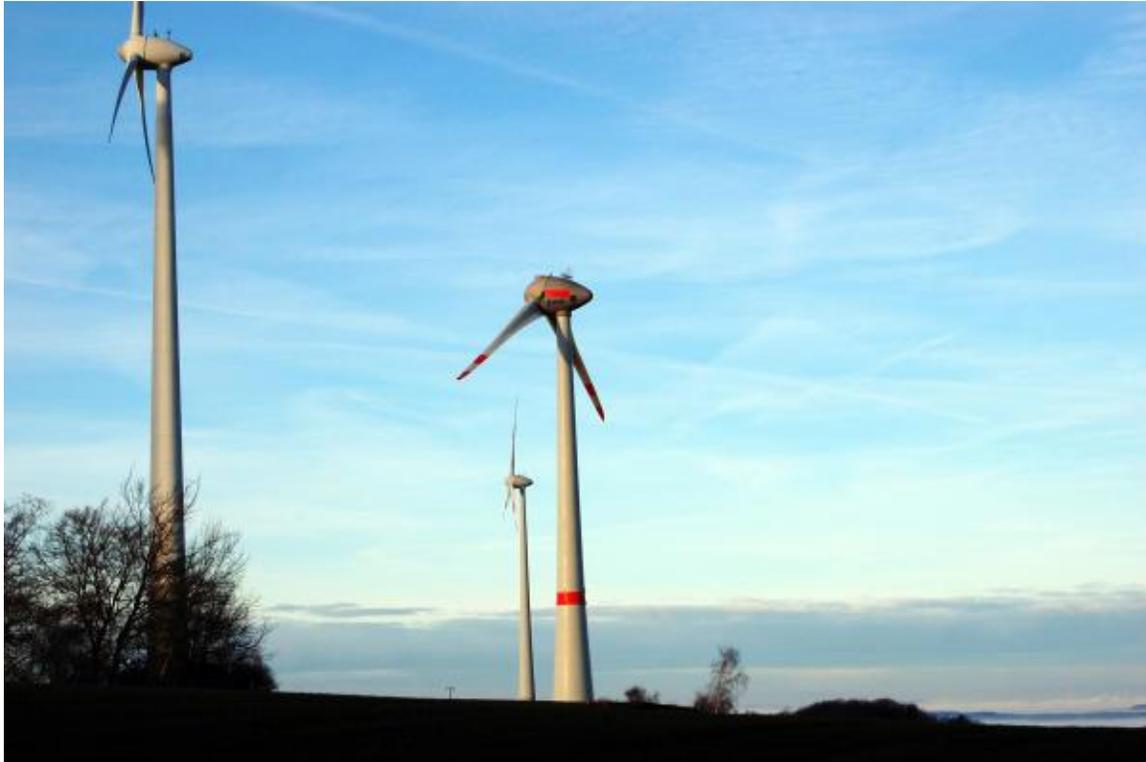
**Fig 5 Enercon E126 in Donnersbergkreis, Rhein- Hunsrück (Germany) 31<sup>st</sup> December 2013. The blade travelled 40 meters and weighed 60 tonnes. The blades are of a segmented steel –composite hybrid build.**

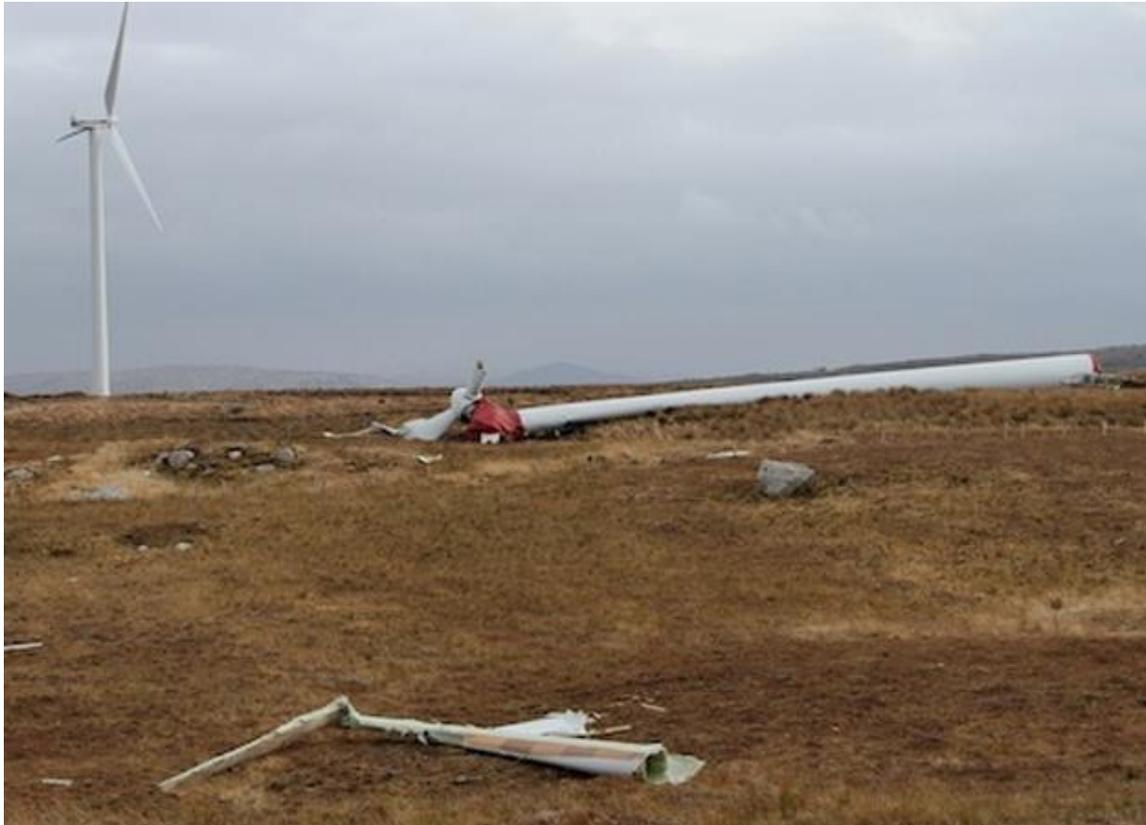
**Fig 6 Loughderryduff. The reason given by Vestas for the collapse is the blade hit tower collapsing the turbine. Probably caused by brake failure.**

The Loughderryduff Wind Turbine collapsed at its cutout speed. The occurrence of winds operating at the cutout speed is significantly more frequent than once in 50 years.

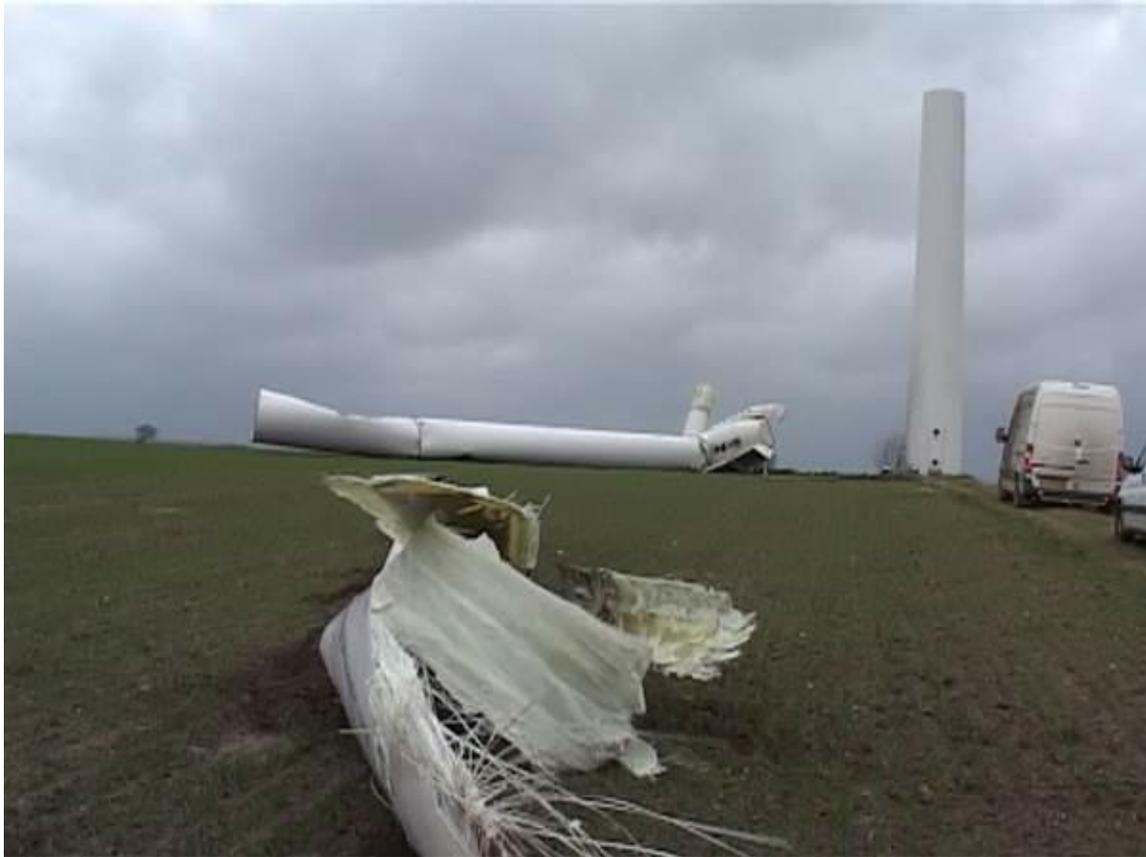
**Fig 7. A 10-Year-old Nordtank/ Vestas Wind Turbine collapses after blade hit the tower. Near Aarhus on the 22<sup>nd</sup> of February 2008**

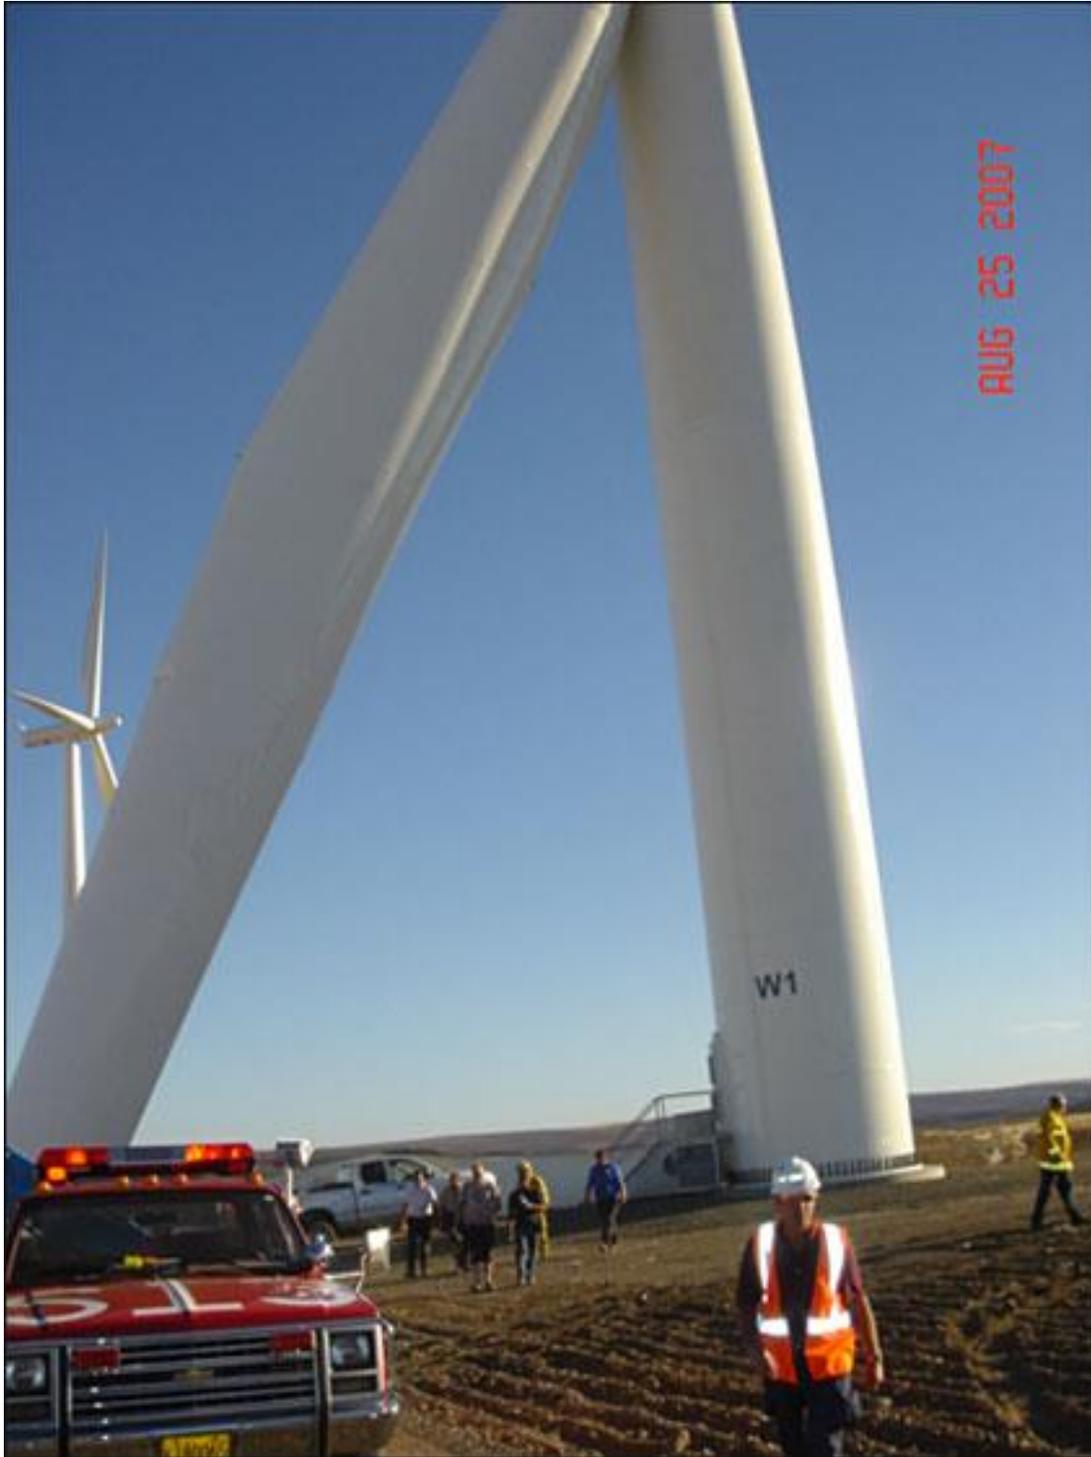
Fig

8. A Siemens wind turbine collapses after the tower being struck by a blade killing one technician and seriously injuring a second in Oregon, U.S.A. 25<sup>th</sup> May 2007. [http://blog.oregonlive.com/breakingnews/2007/08/wasco\\_wind\\_turbine\\_collapse\\_ki.html](http://blog.oregonlive.com/breakingnews/2007/08/wasco_wind_turbine_collapse_ki.html)

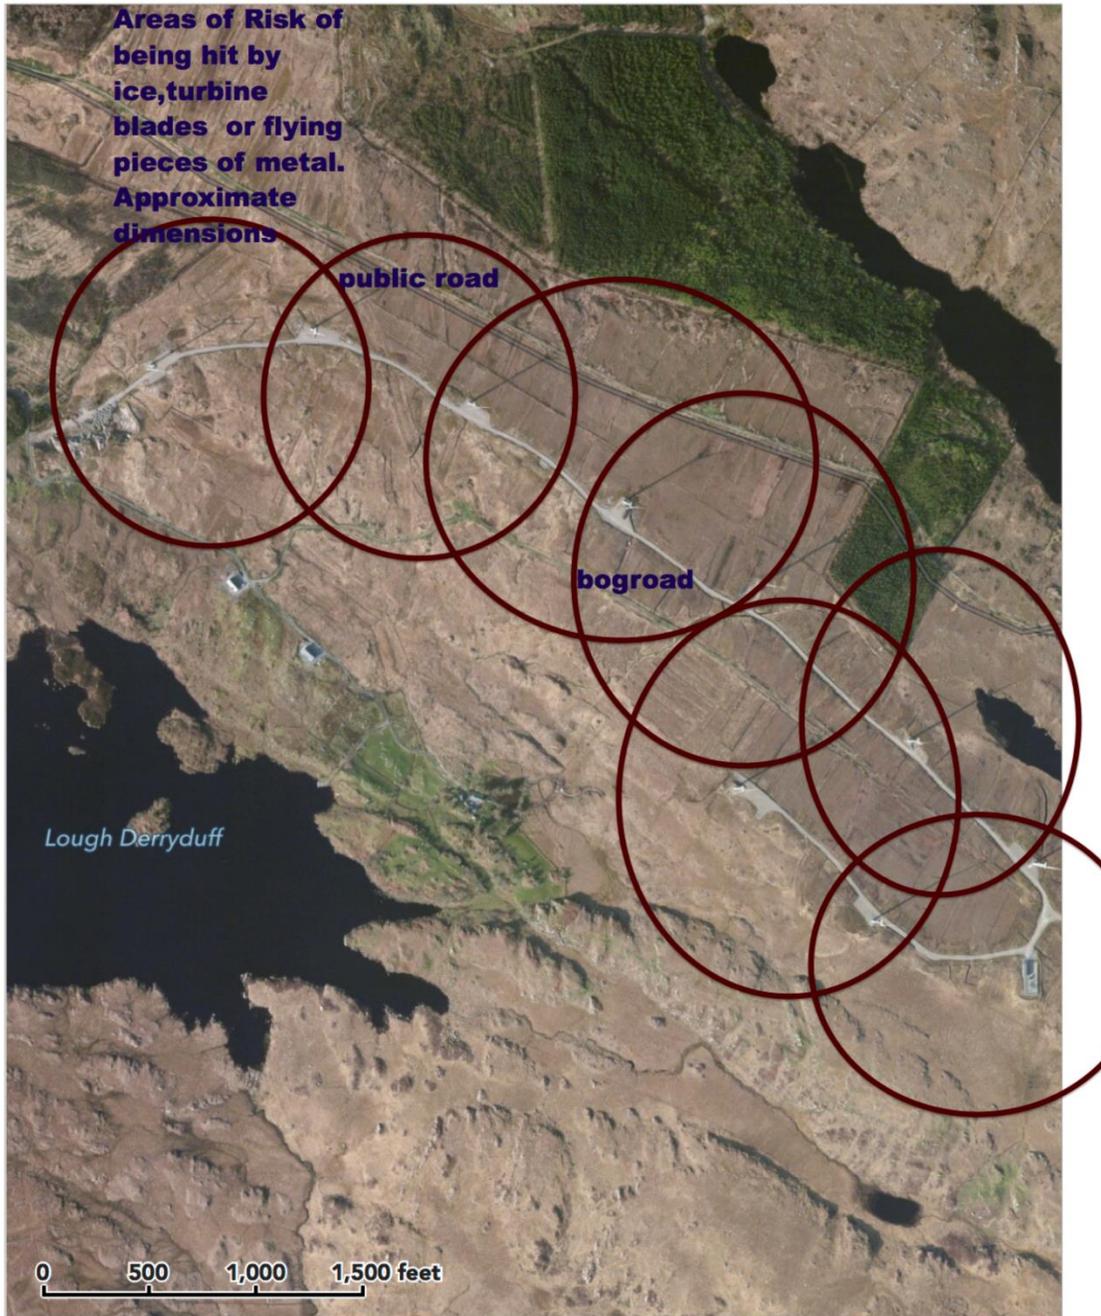
**Fig 9. Risks to humans, domestic animals and property. Areas of risk around Loughderryduff Wind Farm including areas of public access.**

The flight distance of large blade pieces being up to 600 meters and smaller pieces like rivets, bolts and other pieces of materials being up to ONE MILE (1600 meters). Most likely caused by bolts close to the base of the yaw being improperly torqued and flying due to flexing of the tower. The circles on the aerial photograph represent a distance of 600 meters or so. The of being hit by smaller component and other pieces is not shown

Taking Loughderryduff as an example the and the likely distance, 600 meters, of a thrown blade or portion of blade the picture shows the area of risk to humans, domestic animals, dog's sheep, goats,, cattle or property like cars, motorbikes or bicycles.

Therefore an area approximate to that marked our in the aerial picture should be made an exclusion zone. Where the circles intersect once the risk of injury doubles. Where the circles intersect twice the risk of injury trebles.

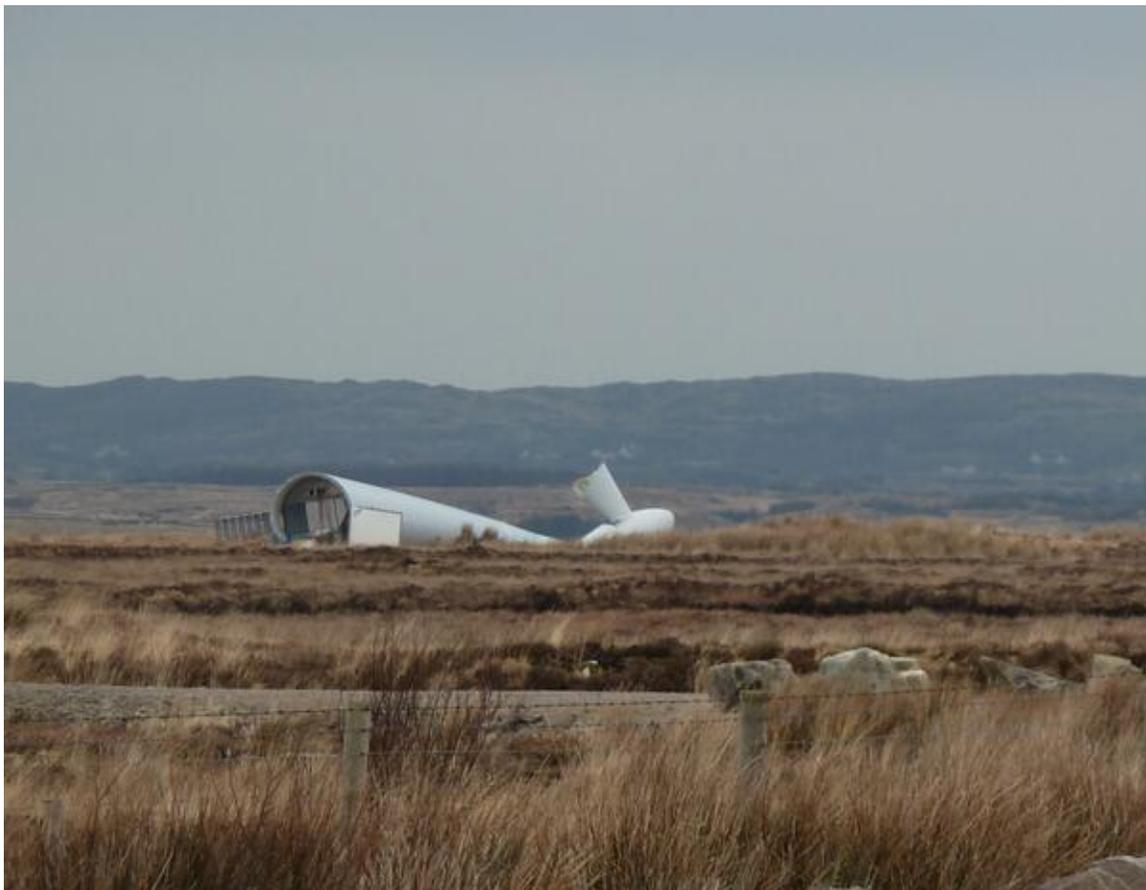
**Fig 10 the closeness of the fallen Turbine Vestas V52 to the road. In considering the risk to buried services due to the risk of damage caused to buried services and exclusion zone of 1.5 times mast height was proposed.**

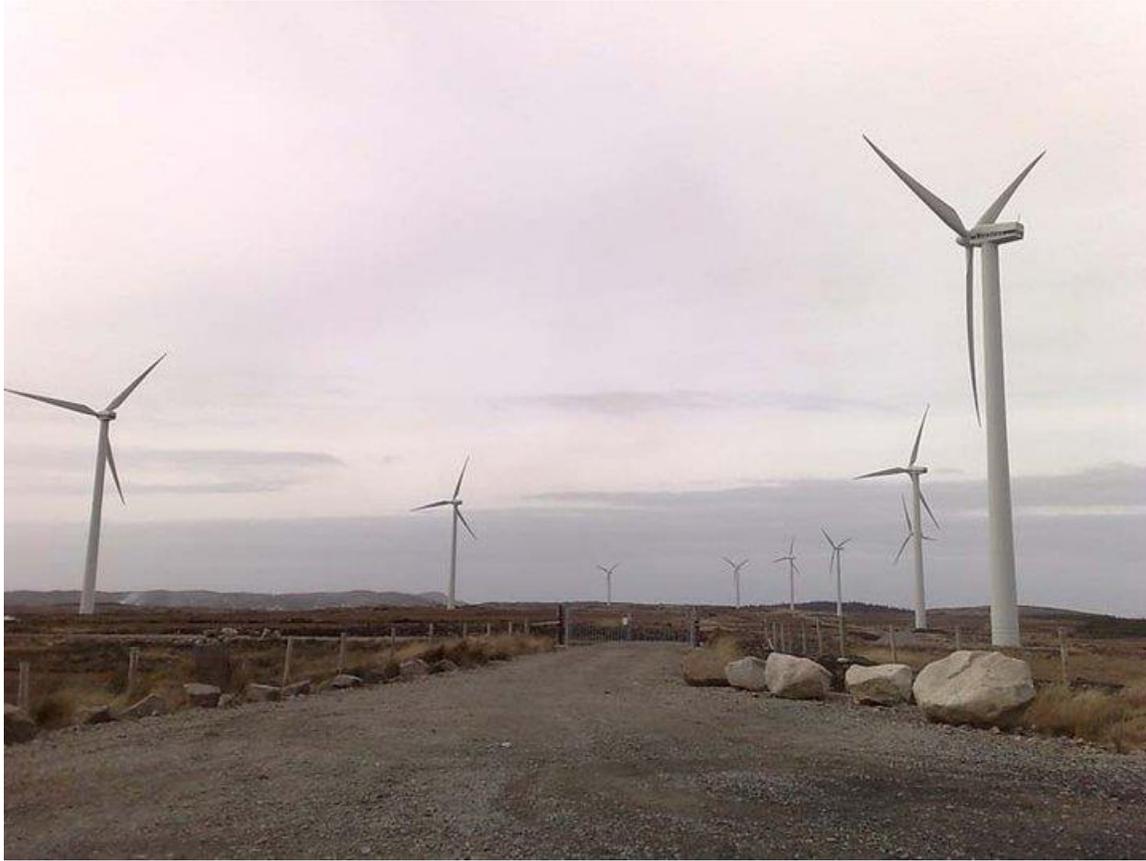
**Fig 11, Loughderryduff Danger Zone. Risk to all human activity on the access road. Risk introduced by the erection of these Industrial Wind Turbines. Zero risk prior to erection of Wind Farm. This area would have an elevated level of risk because of the closeness of the turbines to one another. Access to this road way should be banned.**

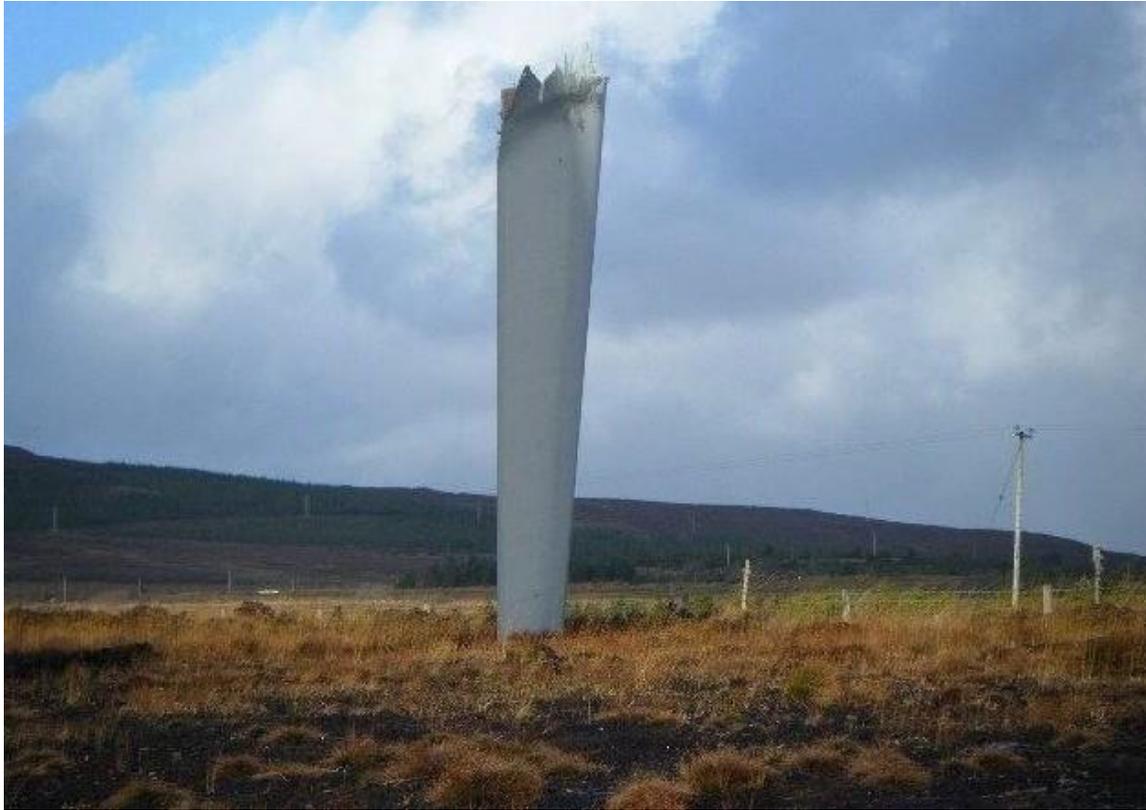
**Fig 13 Corkermore Wind Farm Broken Blade of a Gamesa G80 on the 9/12/2013**  
<http://renews.biz/55803/gamesa-probes-irish-blade-snap/>
