Catchment risk assessment Amlaird WTW

Report produced for Scottish Water

Date: March 2010

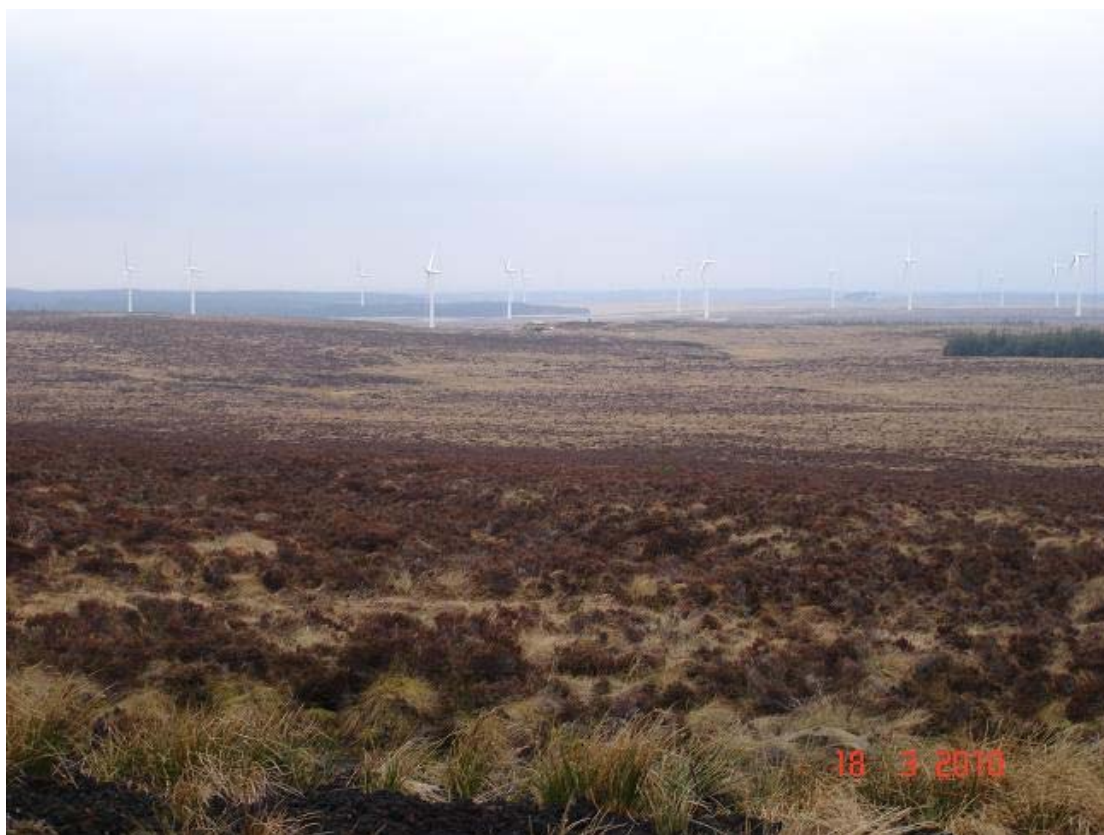
Plate 3. View west from Drumduff Hill (eastern end of catchment – 350 m asl) towards the Craigendunton Reservoir and Lochgoin Farm.

Soils in the Amlaird catchment range from improved organo-mineral soils around Lochgoin Farm to genuine peaty podzol and peat soils on Flow Moss and Drumduff Hill. The catchment is mainly flat to gently sloping with extensive areas of heather moorland and peat bog (Plate 3). Soils vary from genuine peat soils which range from 1m to 7m deep to organo-mineral soils with peaty top layers.

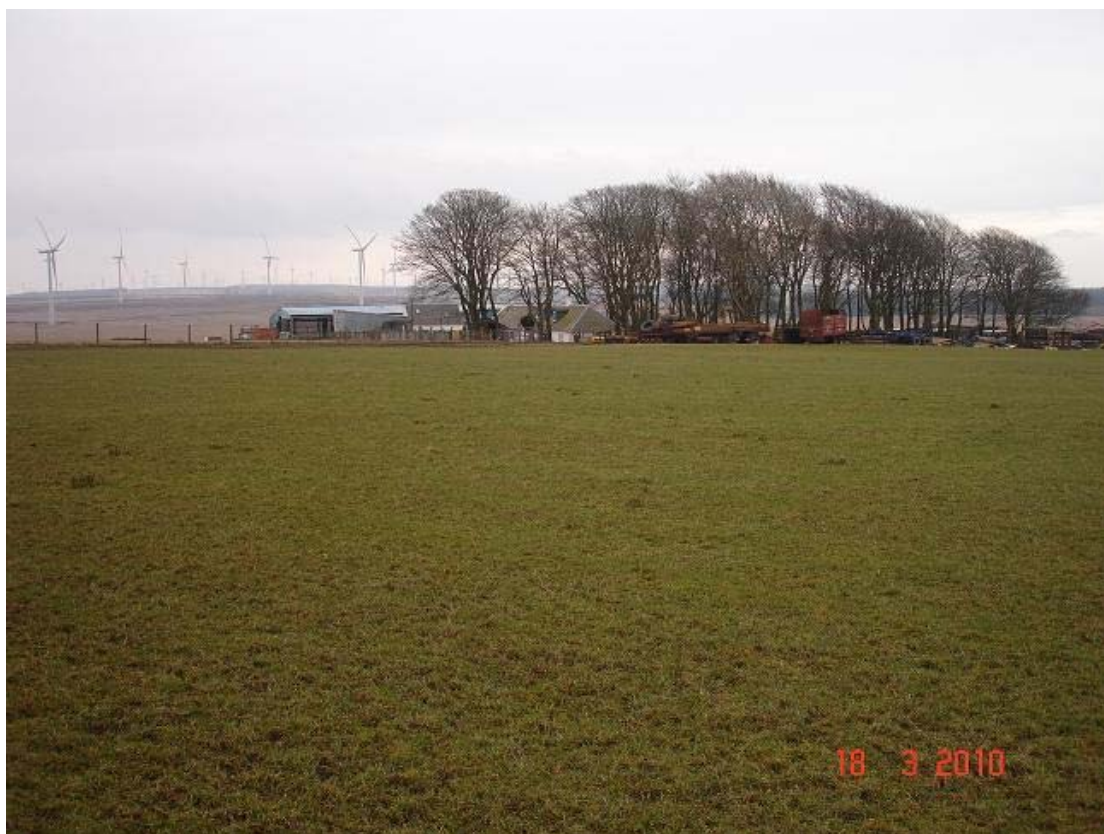
Plate 5. Improved grassland at Lochgoin Farm.

At Lochgoin farm, approximately 500 ewes are grazed on rough moorland grazing and c.40 ha of improved grassland (Plate 5). Lambing takes place in sheds at the farmstead in April and May. Manure is spread to the improved grassland surrounding the farm. Young hogs (ewes that have not yet lambed) and older ewes are grazed on the rough moorland grazing in the summer. There are a few large open drains on the open moorland, but there has been no recent drainage and none is planned.
